TOWN BRANCH AND TRIBUTARIES

FLOOD PLAIN MANAGEMENT STUDY AND DAM BREACH STUDY MADISON COUNTY, TEXAS

April 1988

FLOOD PLAIN MANAGEMENT STUDY,
DAM SAFETY BREACH ROUTINGS OF CONSTRUCTED DAMS
TOWN BRANCH AND TRIBUTARIES
MADISON COUNTY, TEXAS

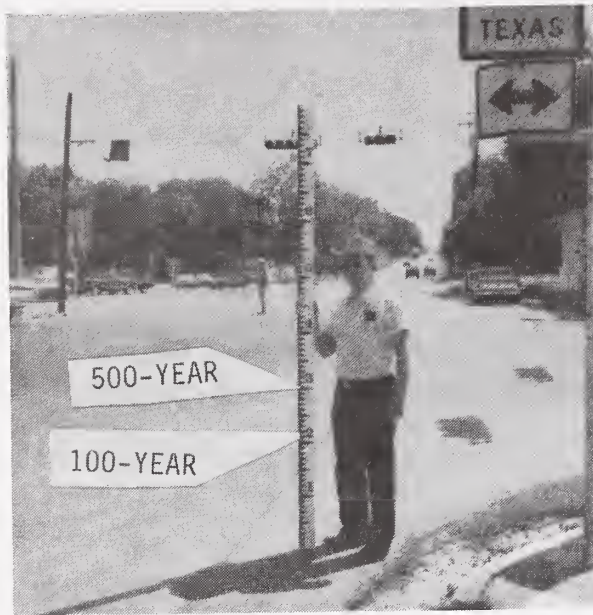
Figure 1 - Potential flood heights at intersection of SH 75 and SH 90.

Potential flood heights for the 100-year and 500-year floods photographed at two locations to illustrate the flood problems are shown on page 10, Figures 1 and 2.

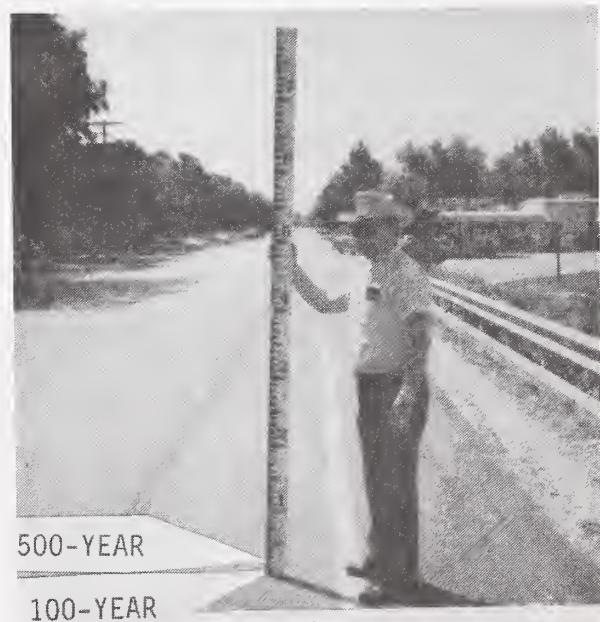
Figure 2 - Potential flood heights at intersection of Town Branch and Madison Street.

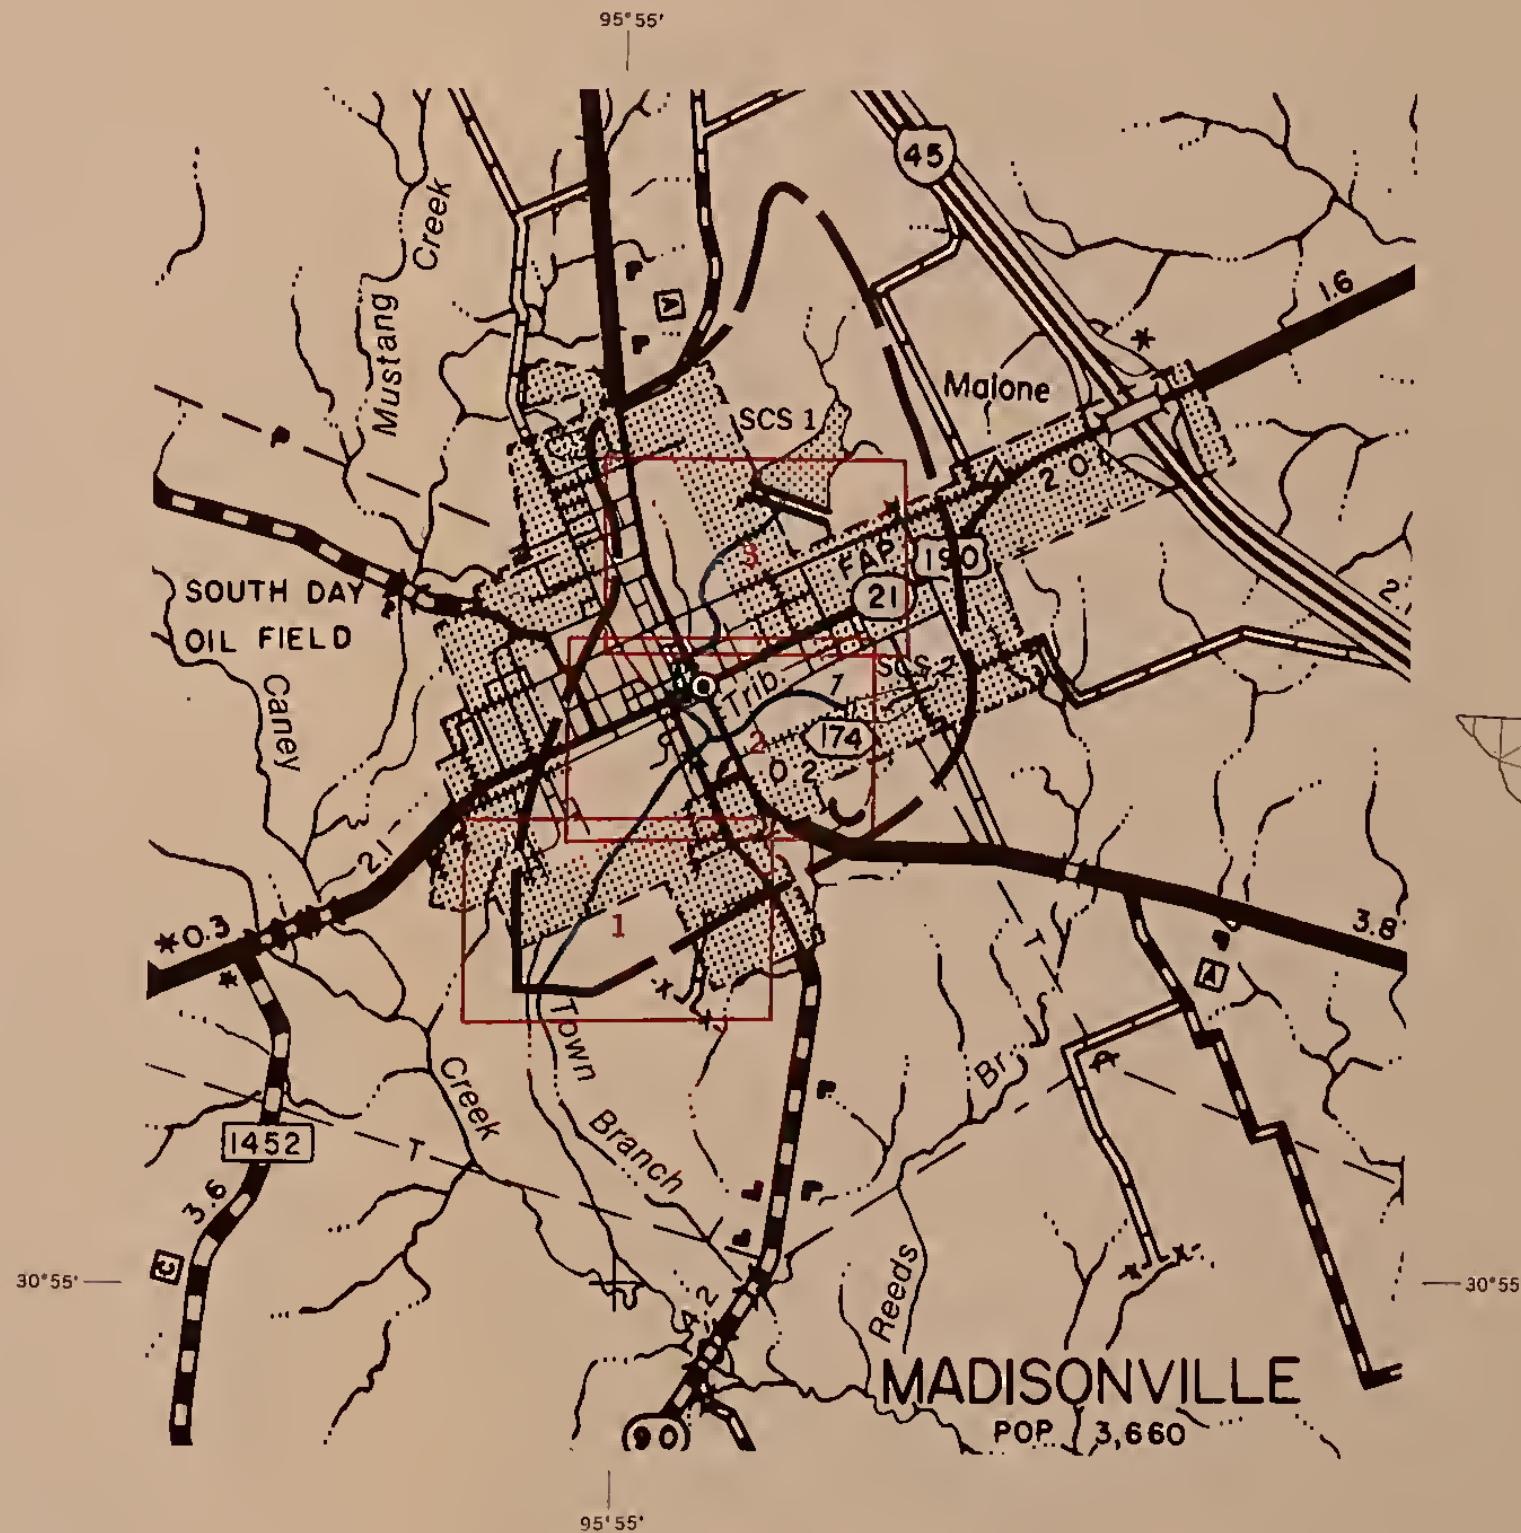
INDEX TO MAP SHEETS
TOWN BRANCH AND TRIBUTARIES
FLOOD PLAIN MANAGEMENT STUDY
 MADISON COUNTY, TEXAS

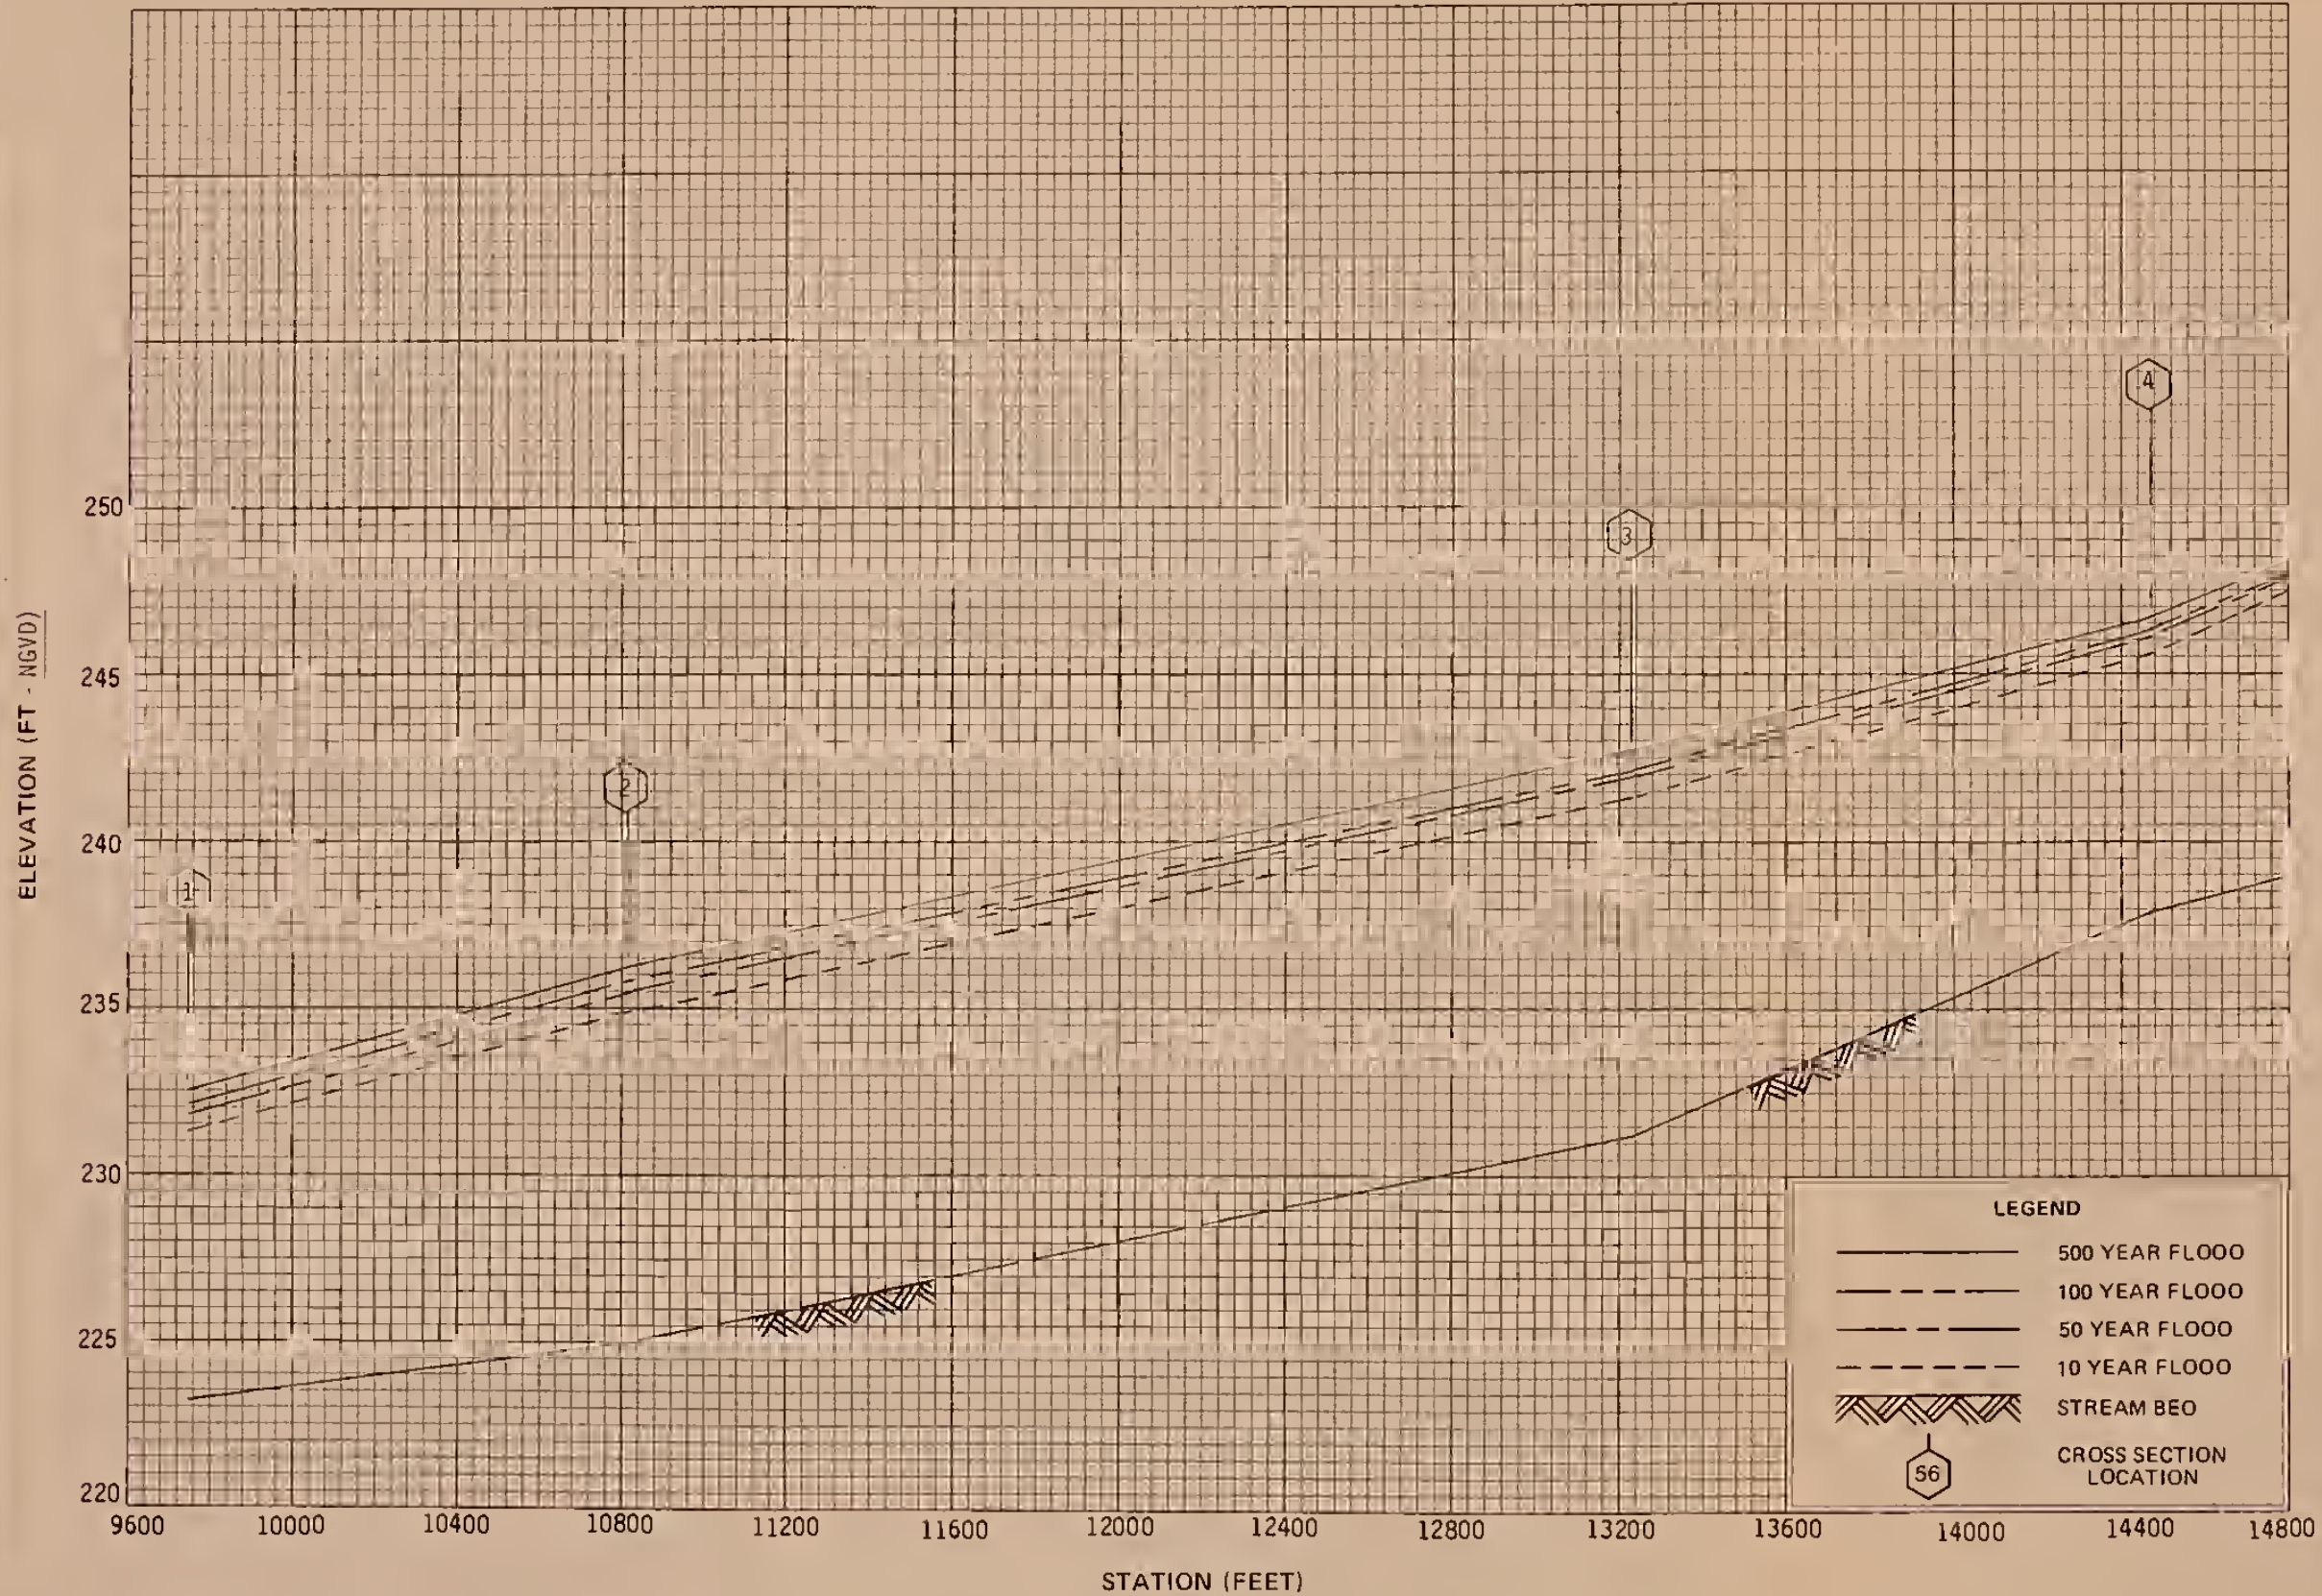
WATER SURFACE PROFILES

TOWN BRANCH

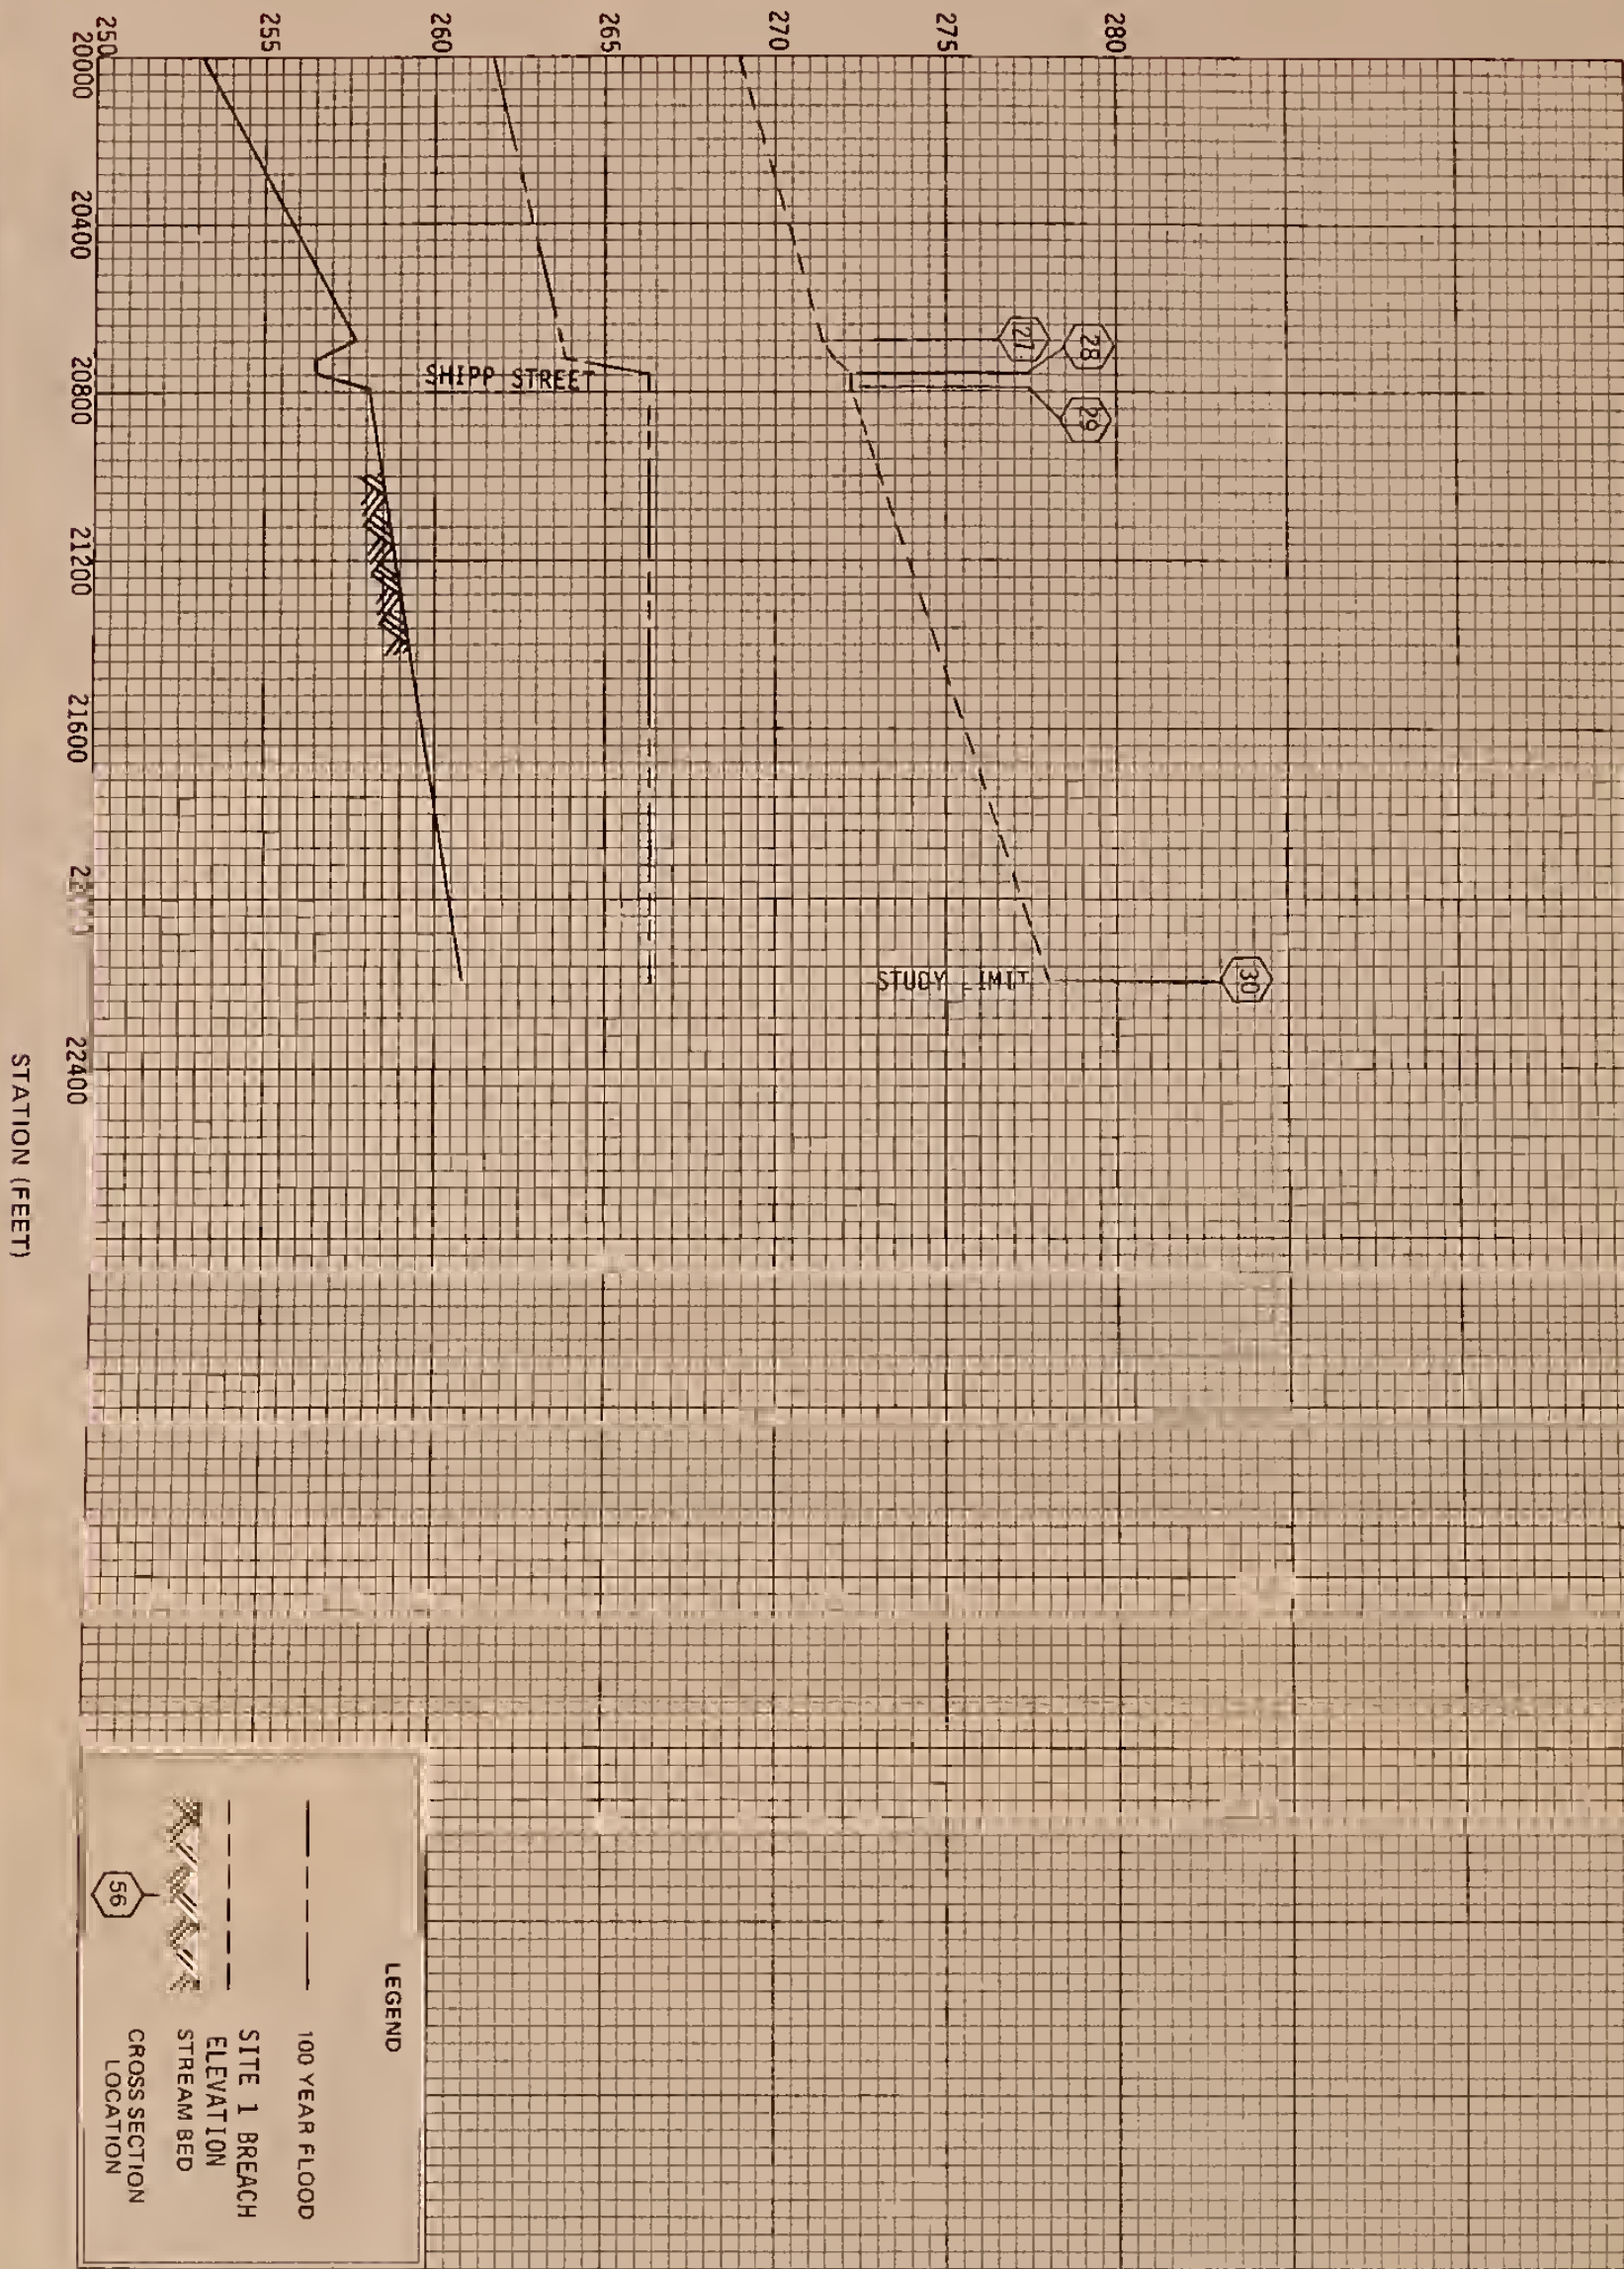
U.S. DEPARTMENT OF AGRICULTURE
SOIL CONSERVATION SERVICE
TOWN BRANCH & TRIBUTARIES
DAM SAFETY BREACH STUDY
MADISON COUNTY, TEXAS

WATER SURFACE PROFILES

SITE 1 BREACH

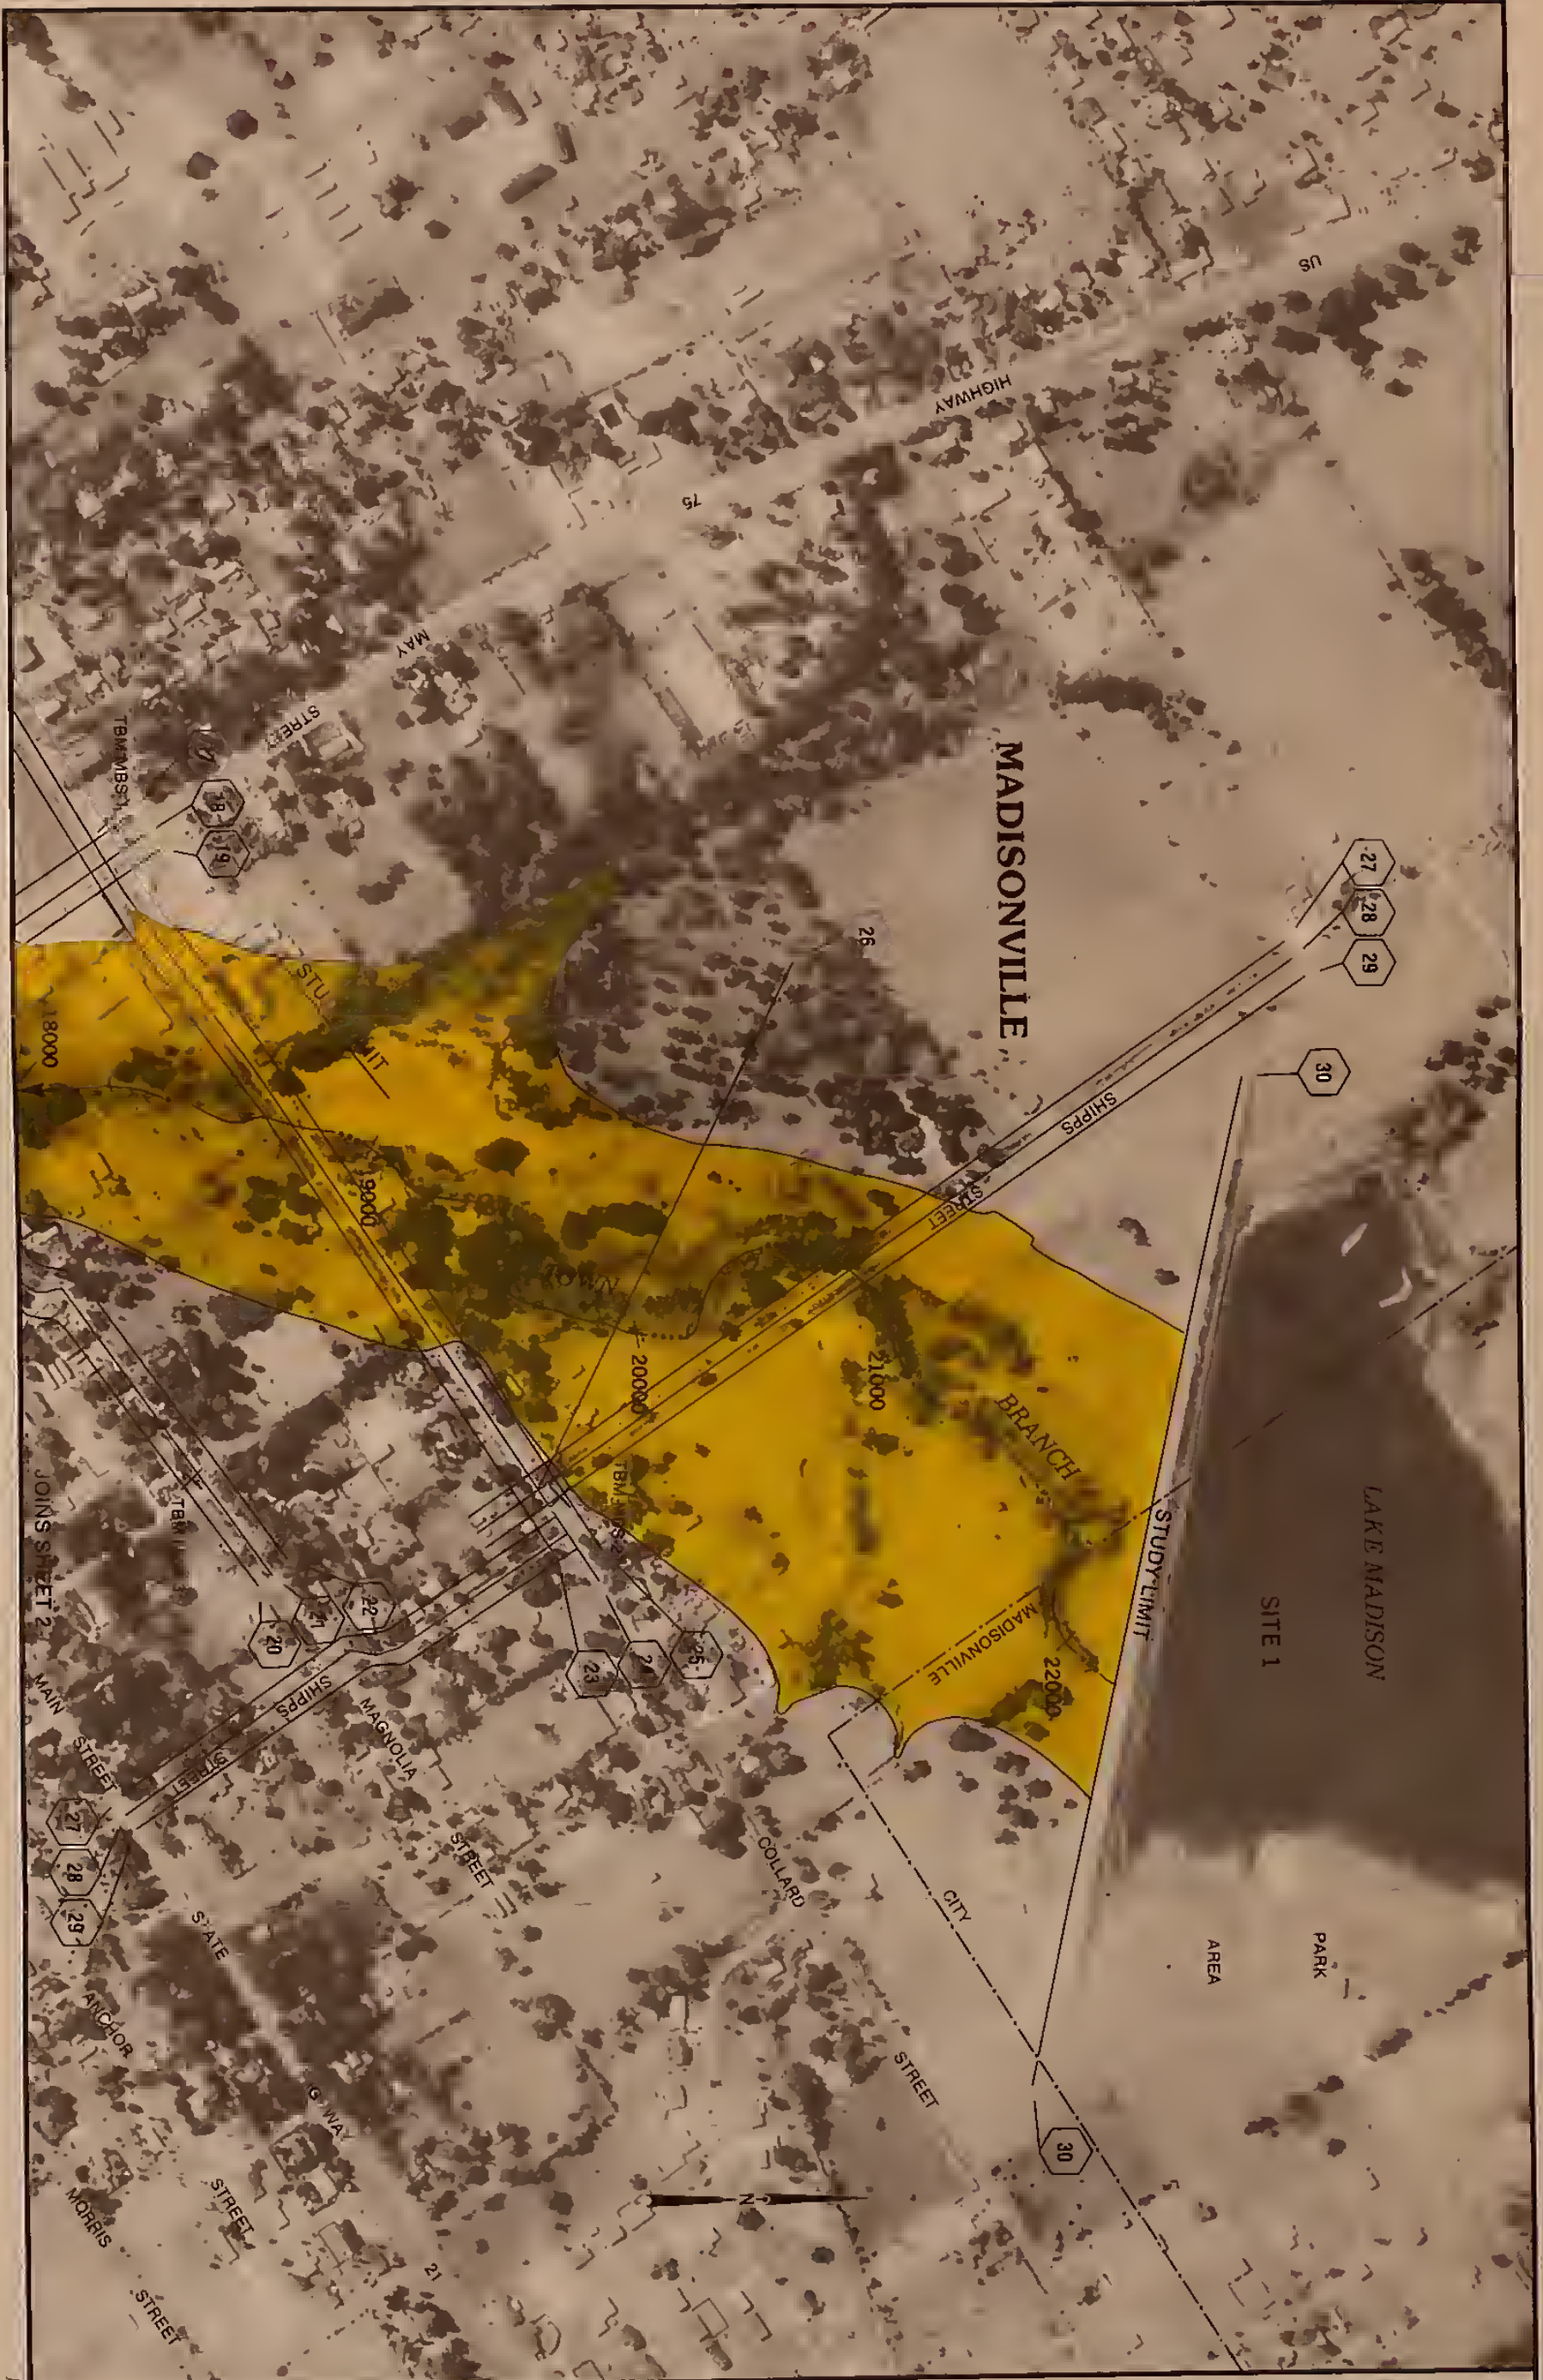
**Site 1 Breach Inundation Area**

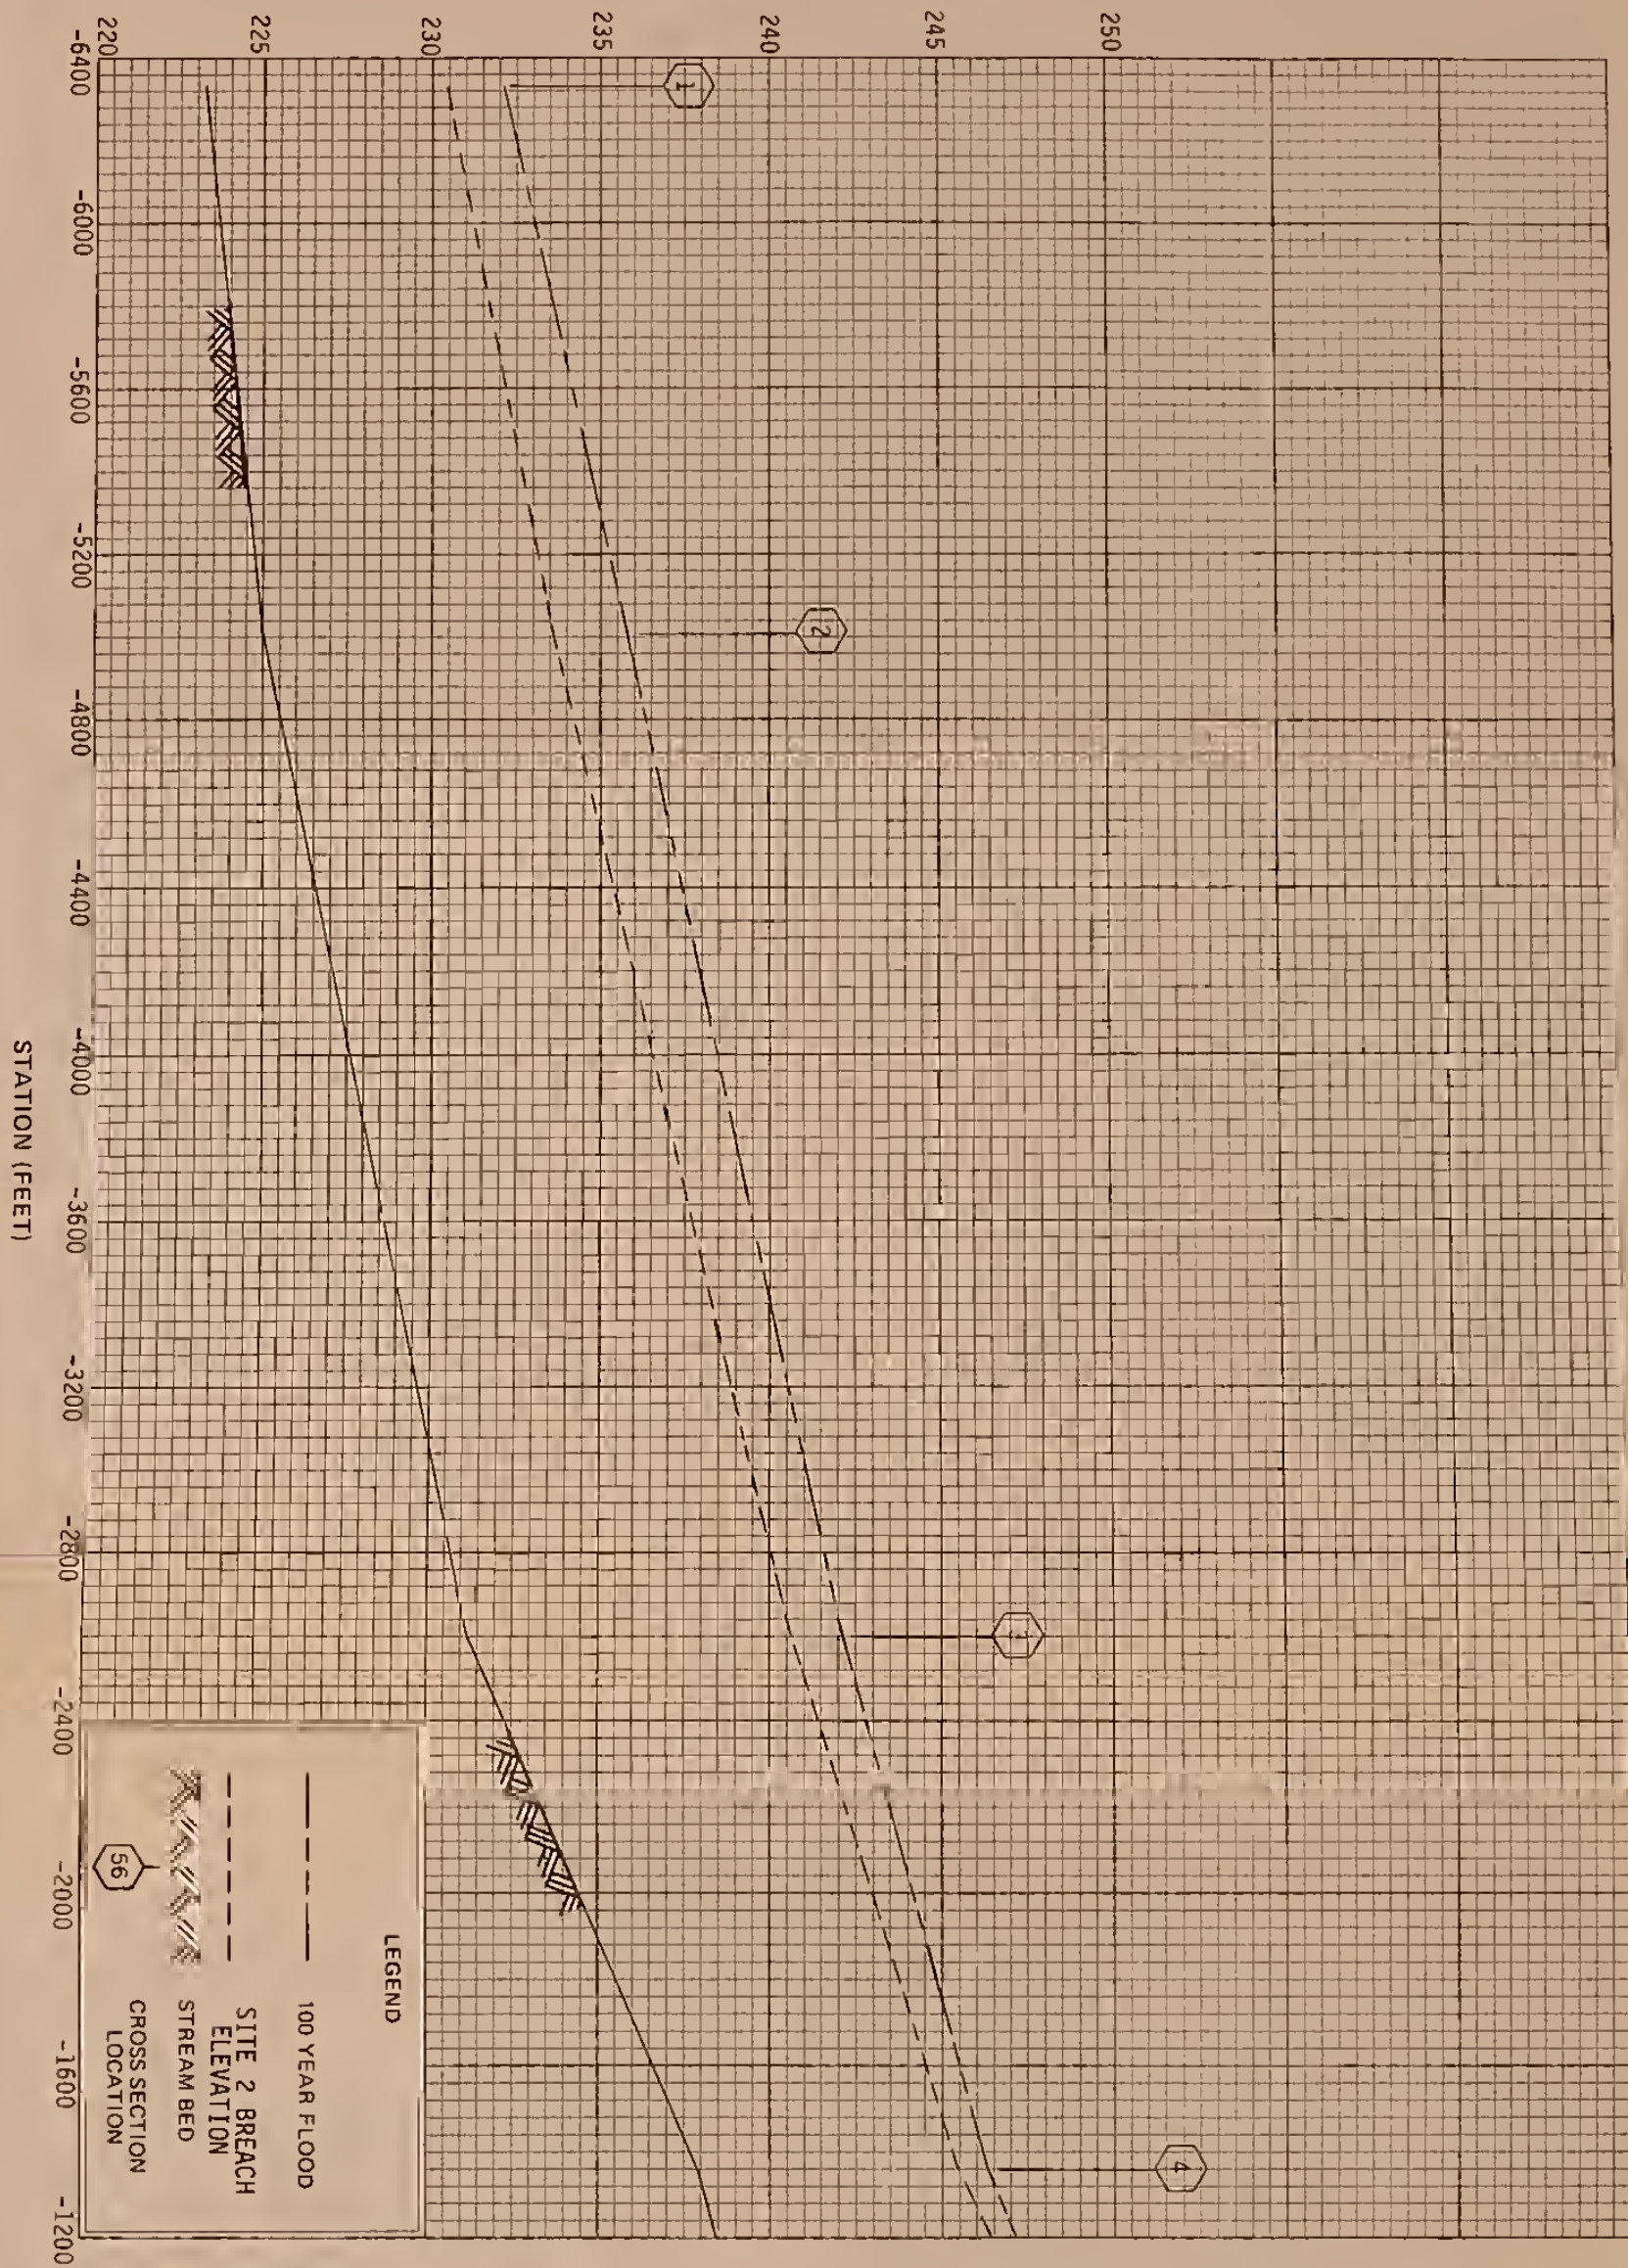
U.S. DEPARTMENT OF AGRICULTURE
SOIL CONSERVATION SERVICE
TOWN BRANCH & TRIBUTARIES
DAM SAFETY BREACH STUDY
MADISON COUNTY, TEXAS

WATER SURFACE PROFILES

SITE 2 BREACH

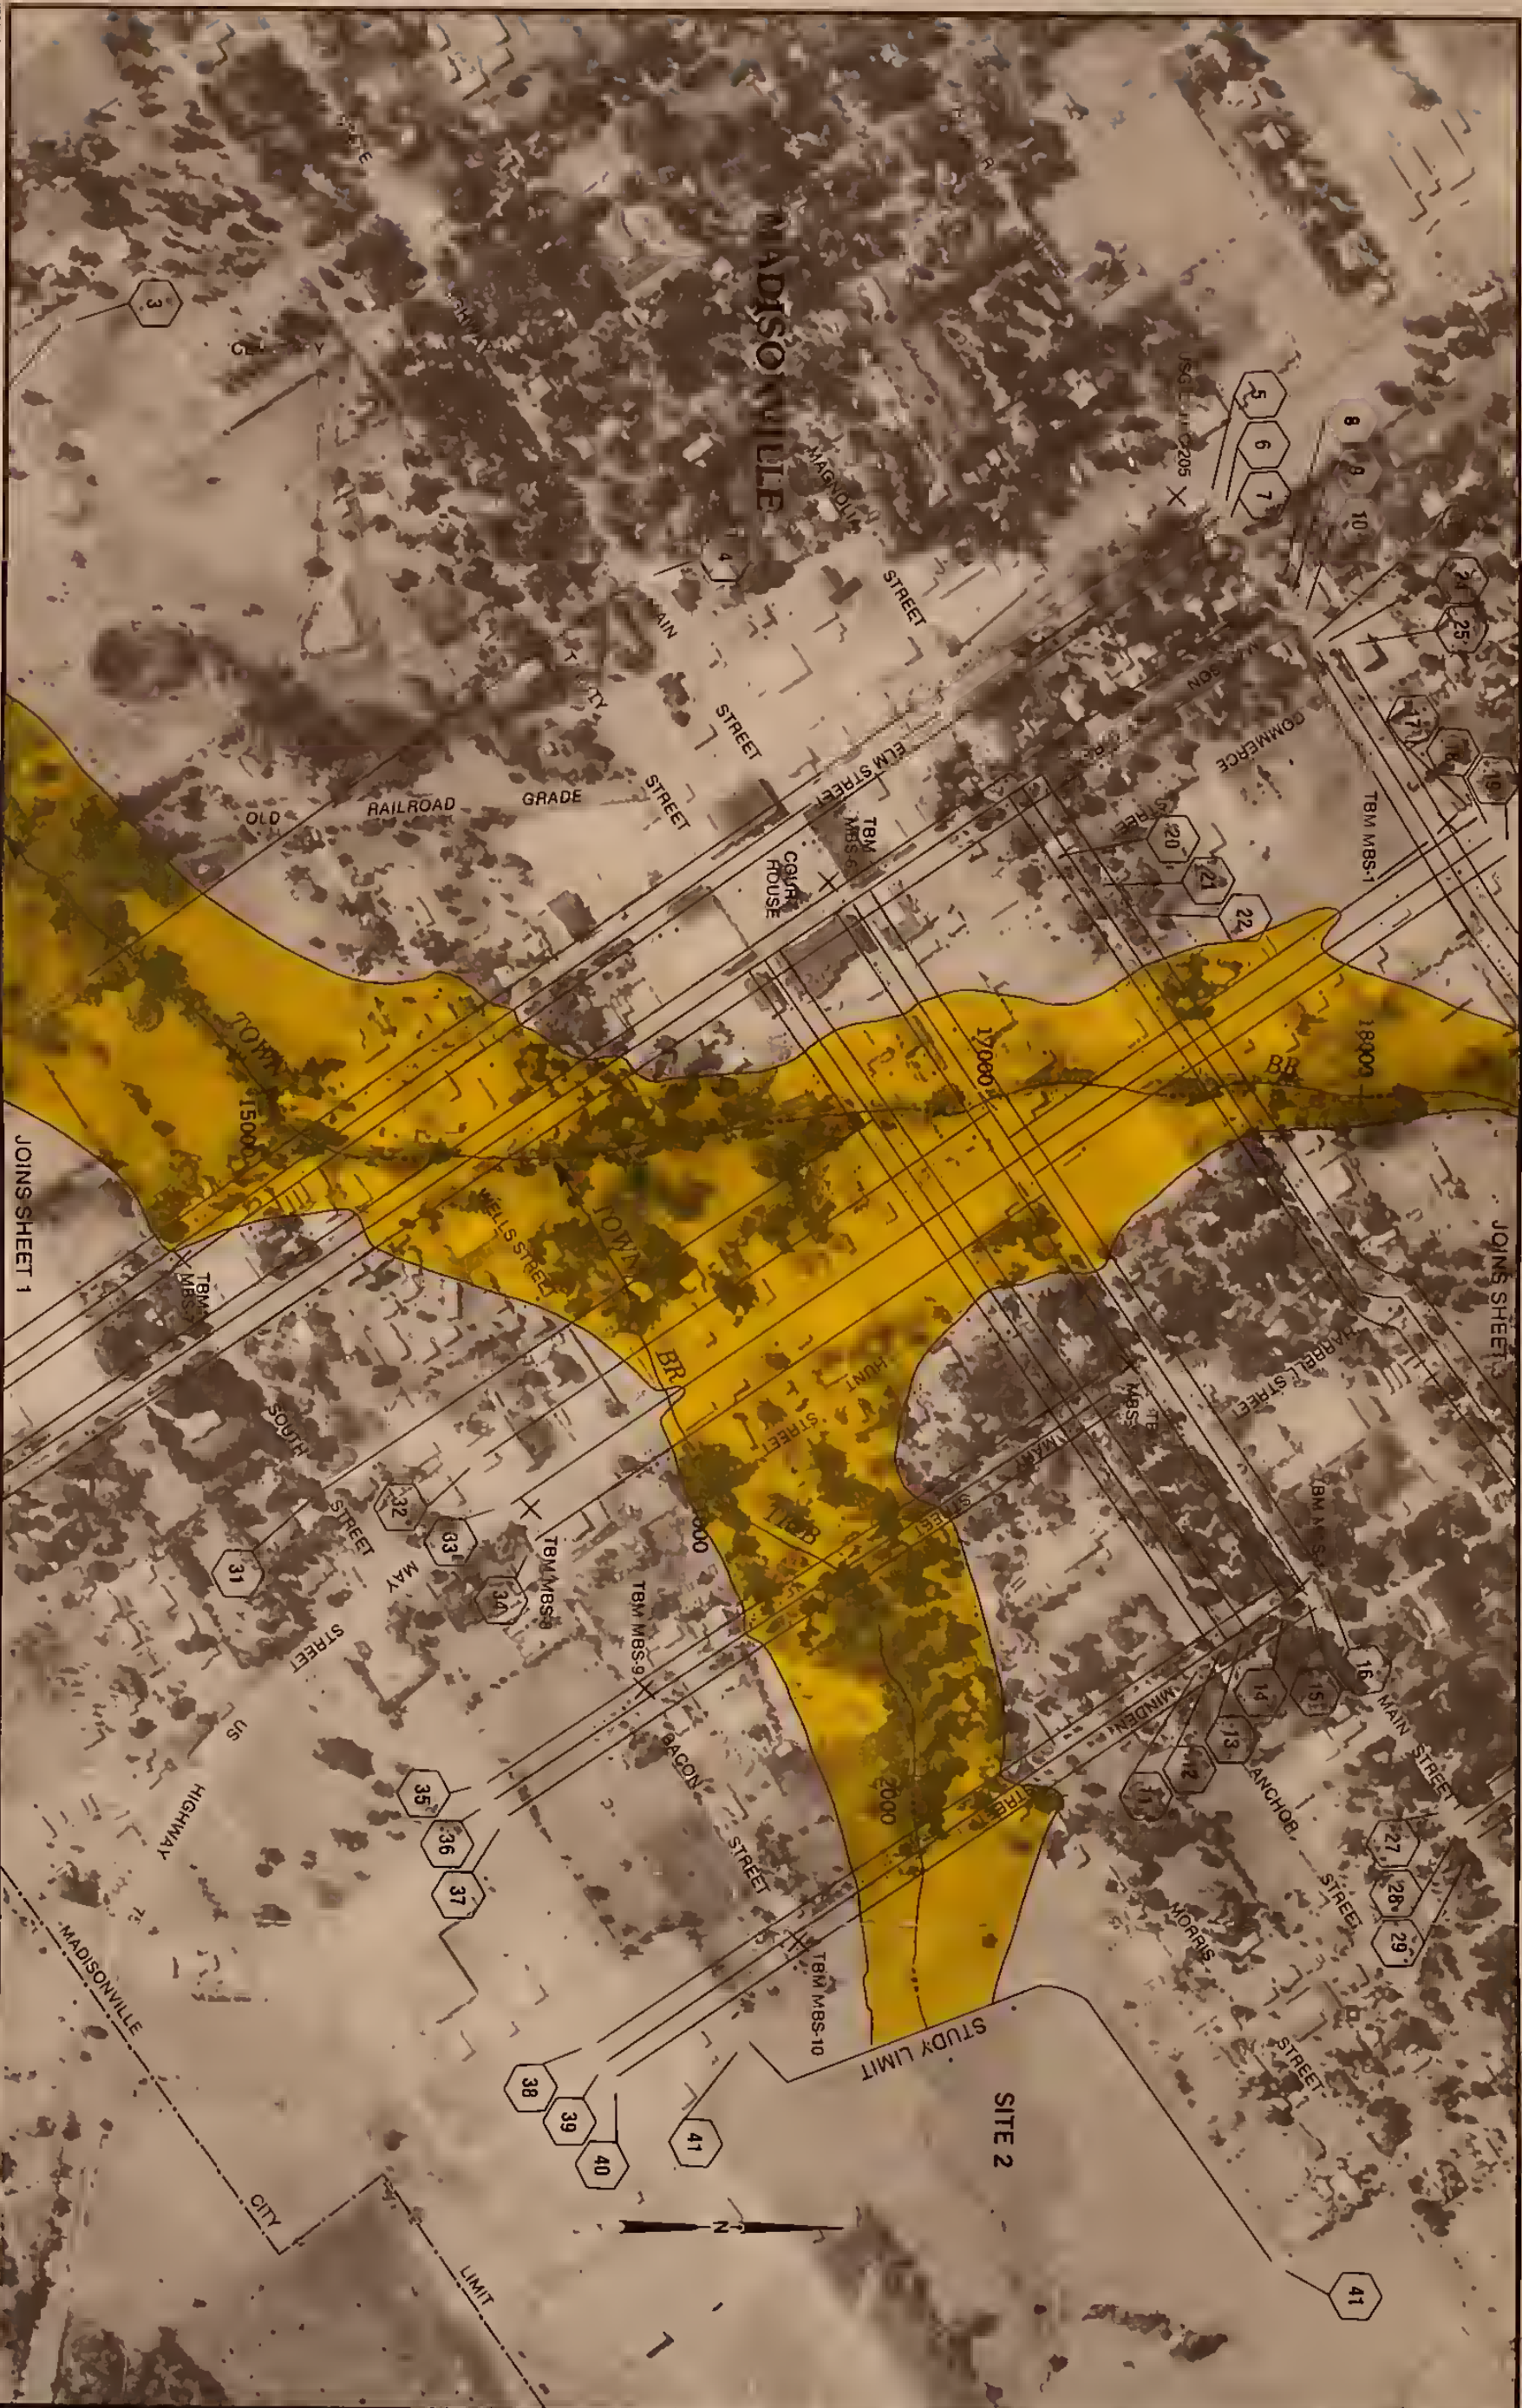
**Site 2 Breach Inundation Area**
